Autopsy of an old reverse osmosis membrane from Cap Djenet seawater desalination plant: case study of Algeria

S. Talantikite¹, K. Benrachedi¹

¹Food Technology Research Laboratory (LRTA) Faculty of Sciences Engineer
University of M'hamed Bougara, Boumerdes, 35000 Boumerdes–Algeria

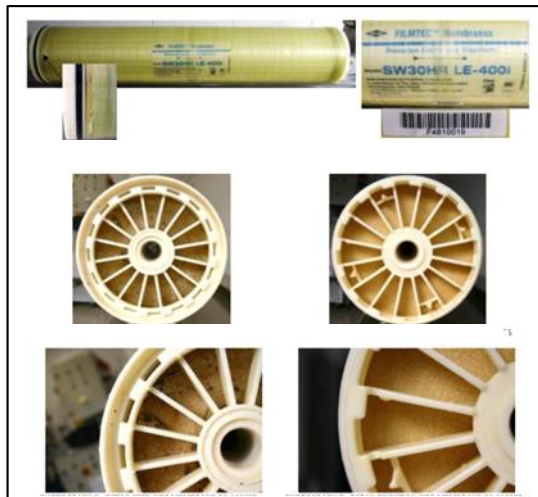
(a)

- some fissures were detected on external housing (feed end).
- presence of some particles which was observed on element feed end (photographs 3 and 5).
- no telescoping or significant spacer protrusion was detected.

Figure 2. Fouled membrane of cap Djenet desalination plant: visual external inspection (a); visual internal inspection (b).

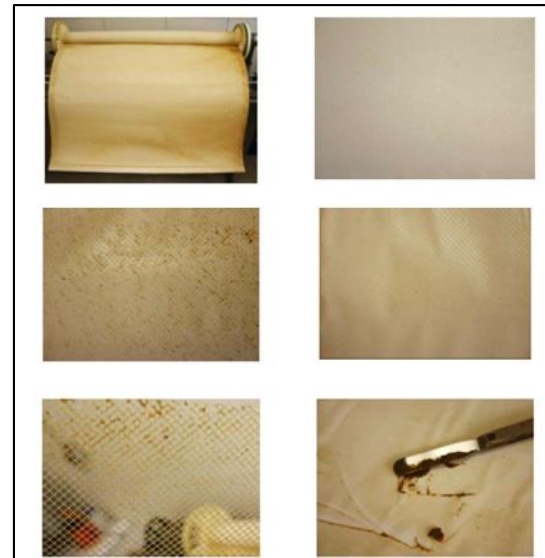
(b)

- Presence of brown fouling was detected all over the surface. Same kind of fouling was observed on spacer material, mainly on feed side.
- Presence of a black mass that at first glance appeared like a bacterial colony. A similar results were observed by previous studies [12,13]. Some studies suggest that this phenomenon was ascribed to the foulants which have been deposited on the membrane surface rather than formed by a precipitation mechanism [14].
- No additional details were observed on membrane surface. No significant failures were detected.

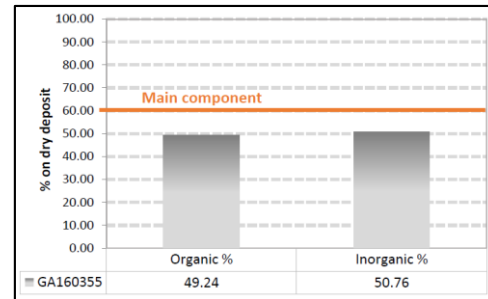
Figure 3. LOI results obtained from GA160355 membrane fouling

The Figure 3 describes LOI data obtained for GA160355 (1st position) fouling data. Considering these results, fouling from GA160355 membrane surface shows similar organic and inorganic content.

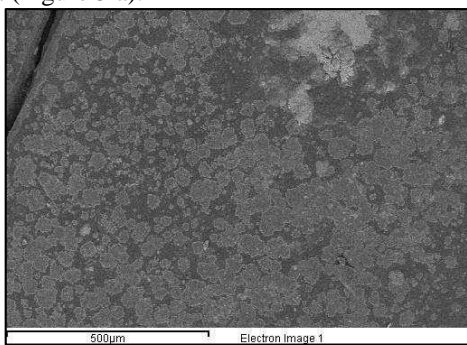
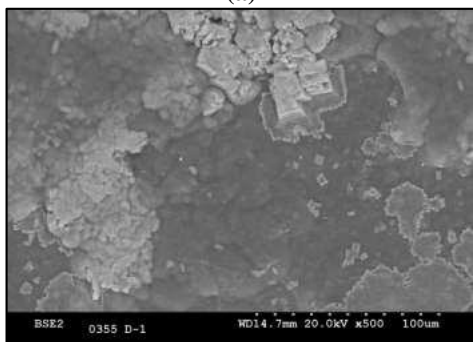
The SEM micrograph of fouling from membrane surface shows an organic fouling mixed with sodium chloride from sea water.

There is also presence of aluminosilicates and common elements on sea water membranes (Figure 4 (a) and (b)).

The SEM Microphotograph 2F of membrane fouling shows that fouling looks organic with presence of inorganic crystalline structures (Figure 4 (b)).

Figure 4. SEM Microphotograph of membrane fouling; Microphotograph 1F- General view of GA160355 (1st position) fouling from membrane surface– General analysis: Spectrum 1F (a); Microphotograph 2F. Detail of GA160355 (1st position) membrane fouling: Spectrum 2F (b); Microphotograph 1 General view of Particules (c).

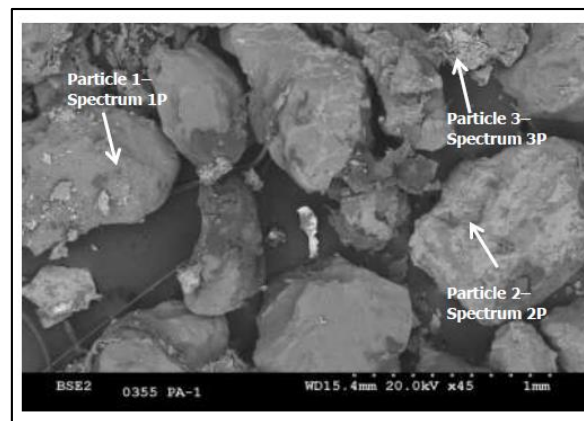
(c)

The SEM micrograph of particules from feed end showed grains with presence of organic matter, sodium chloride, silica and metallic components.

They are probably fouled silica grains (Figure 4 (c))

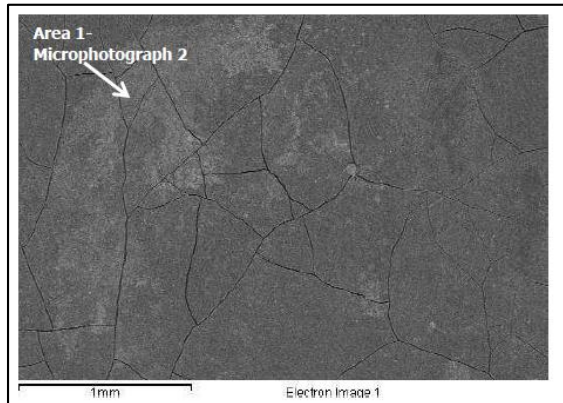
(a)

As the images shown, membrane surface is covered by thin organic fouling that didn't allow distinguishing membrane structure. On this thin organic covering, there is presence of sodium chloride dendritic growing characteristic of seawater membranes surface and some particles of different composition were detected also.

The general view of GA160355 membrane surface showed that there is a significant covering of membrane surface which shows inorganic component more concentrated on spacer support area (Figure 5 a).

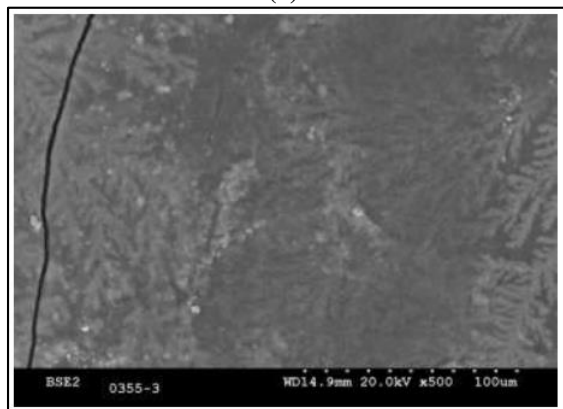
(b)

The second SEM micrograph of the surface of the fouled membrane (Figure 5 b) showed the detail of fouling on area 1 – spacer support area Inorganic component of fouling is concentrated on spacer support area.

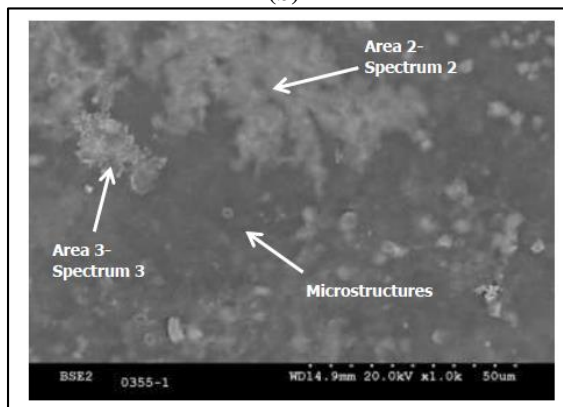
(c)

The third SEM microphotograph of the surface of the fouled membrane (Figure 5 c) showed the detail of fouling on spacer support area. The figure 5c shows that fouling is composed by a mixture of an organic component with very small particles and presence of microstructures.

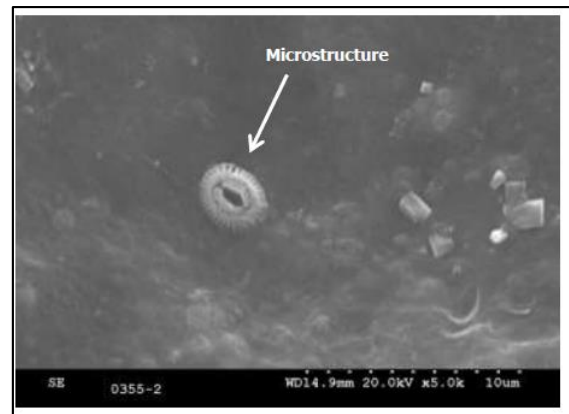
(d)

The last SEM microphotograph of the surface of the fouled membrane (Figure 5 d) showed the detail of membrane surface at high magnifications on area with thin organic covering. It's revealed that on none of the areas, membrane structure couldn't be distinguished. There is also presence of microstructures.

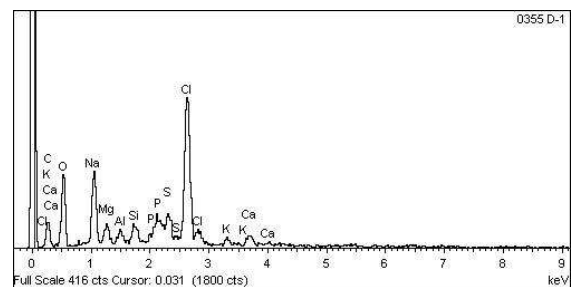
Figure 6-General analysis of GA160355 membrane fouling (Spectrum 1F)

The general analysis of GA160355 membrane fouling indicates that fouling is composed by an organic component, sodium chloride, aluminosilicates, calcium, and common elements on sea water membranes fouling as sulphur, magnesium, phosphorous and potassium (Figure 6). While the analysis of area 1 on GA160355 membrane fouling indicates that fouling is composed by an organic component with chlorine, sodium chloride small percentages of the rest of elements detected on the general analysis carried out on membrane surface sample (Figure 7).

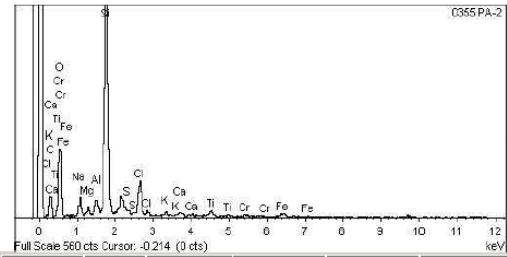
Figure 9. Analysis of particle 2 from GA160355 membrane feed end

The analysis of particle 2 from GA 160355 is mainly composed of silica, with small percentages of sodium chloride and iron and aluminosilicates (Figure 9).

Spectrum 2P.- Analysis of particle 2 on GA 160355 membrane feed end. Mainly composed of silica, with small percentages of sodium chloride and iron and aluminosilicates

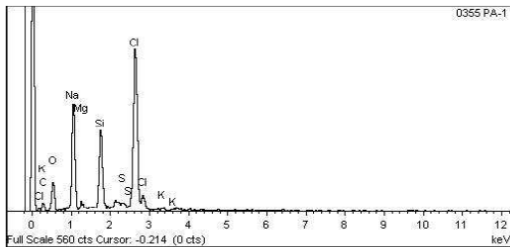
Figure 8. Analysis of particle 1 from GA160355 membrane feed end

The analysis of particle 1 from GA 160355 showed the major constituents to be sodium chloride and silica (Figure 8).

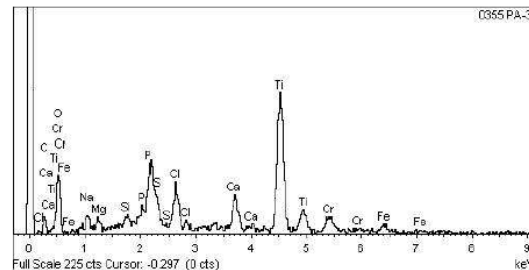
Figure 10. Analysis of particle 3 from GA160355 membrane feed end

While the last particle 3, metallic particle was composed of titanium with small percentages of chromium and iron. We found also presence of sodium chloride, calcium phosphorous, magnesium (Figure 10).

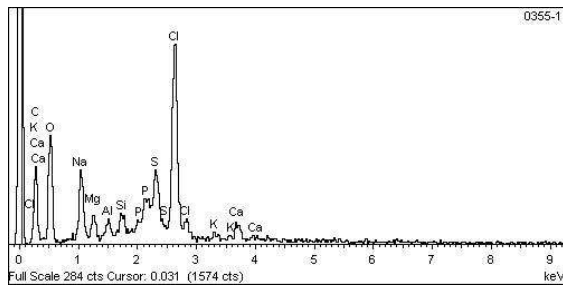
Figure 11. EDS General analysis of GA 160355 membrane surface.

The EDS analysis of membrane surface shows that the fouled membrane surface consisted of

membrane components (carbon, oxygen and sulphur), sodium chloride, chlorine, aluminosilicates and common elements on sea water membranes fouling (magnesium, calcium and potassium)(Figure 11).

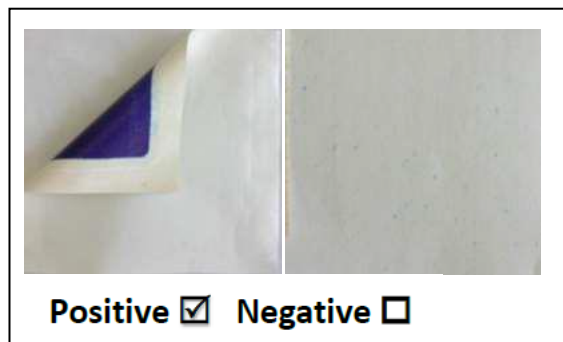
Figure 14. Methylene Blue Test of used fouled membrane

Methylene Blue test detects if the membrane is damaged. The test will be positive if dye presence (blue colour) is detected on the permeate side. As shown in figure 14, the passage of dye was detected on GA160355 permeate side, which verifies that membrane has suffered some damage.

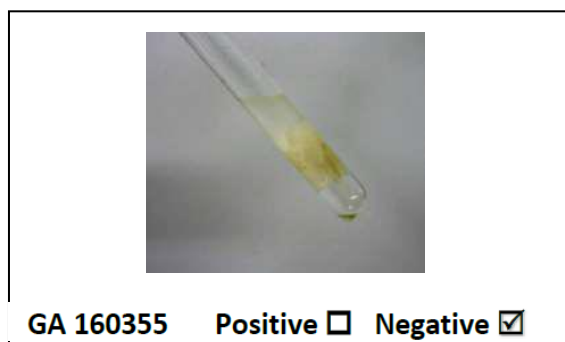
Figure 15. Fujiwara Test of used fouled membrane

Fujiwara Test (FJ) detects significant levels of polyhalogen compounds. This is a colorimetric test in which a pink colour in the analytical solution indicates organically bound halogens. FJ test is always carried out on RO water rinsed membrane samples and without deposit (physically removed). The result showed no pink color was observed on the analytical solution, so contact of fouled membrane GA160355 with halogens was not detected.

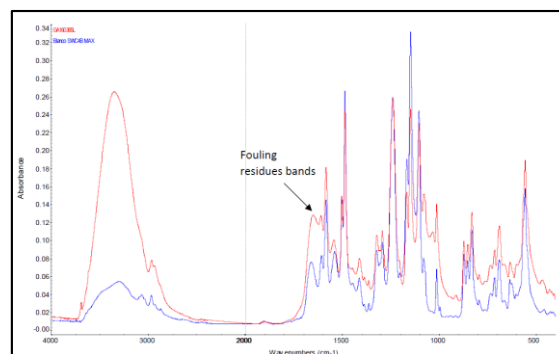
As shown in Figure 16, surface spectrum still shows some fouling residues, which don't allow checking polyamide bands conditions.

Figure 16. Comparison of ga 160355 membrane ir spectrum after a mechanical cleaning (red line) compared to membrane blank (blue line).
