Assessment of the Degraded High-Pressure Blades in a Land-Based Gas Turbine

Abstract The purpose of this paper is to evaluate high-pressure turbine blades after a long-term thermal exposure in a land-based gas turbine. Emphasis is placed upon structure and composition of the various layers evolving, on the one hand, due to hot oxidation/corrosion attacks and, on the other hand, because of interdiffusion phenomena between the substrates and their protective coatings. This work therefore discusses the influence of γ' -Ni₃ (Al, Ti) precipitates coarsening, needle σ -phase nucleation, and M₂₃C₆-Carbides formation on the hardness properties of blades. In addition, this assessment attempts to evaluate the influence of γ' -Ni₃ (Al, Ti) orientation changes and crystallites size growth on the intrinsic degradation of GTD-111 and IN738LC substrates.

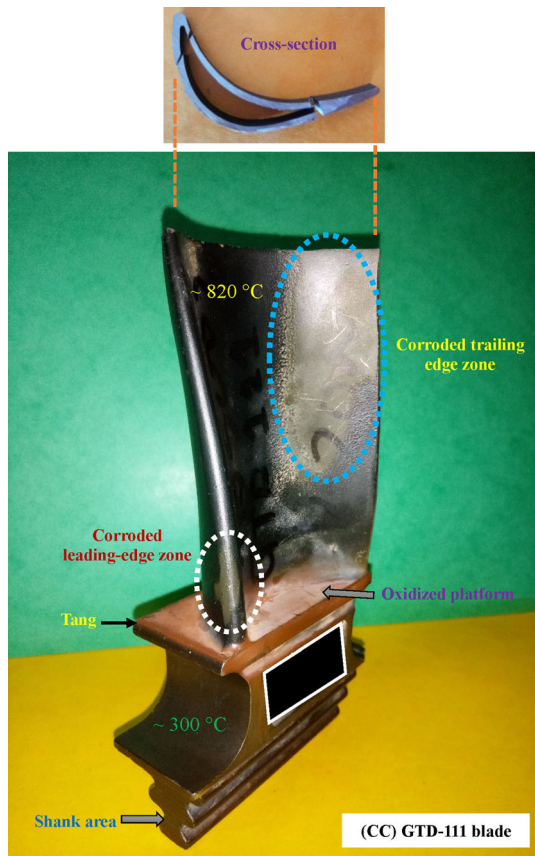
Fig. 1 Degraded GTD-111 blade

The degraded blades exhibit a hollow interior as shown in Figs. 1 and 2. In the as-received condition, the (CC) GTD-111 blade displayed severe hot corrosion attacks at the airfoil hot section (blue and white circles). Furthermore, the airfoil region is black in color with a bit of brownish-red color. The shank zone did not show any discoloration or deformation (unaffected). The blade coating was corroded and stripped off the airfoil in some areas due to the

The visual examination of GTD-111 blade shows the presence of a black color at the airfoil section, as shown in Fig. 1. This color is attributed to the VPS coating oxidation

during operation at 820 °C. The presence of red deposits in the platform region is thought to be a result of ingestion of the mineral debris (dust, sand, and ash) contained in the hot gases arriving to the gas turbine. The severe corrosion attacks that took place at the airfoil (the blue and white circle) was a result of the alkali metal contaminants (such as Na_2SO_4) deposition at the outer surface. The thermally unaffected shank zone (~ 300 °C) remains sound. However, the stage 1 blade shown in Fig. 2 revealed a dark-brown color at the airfoil section. This is a sign of the high-temperature oxidation of NiPtAl protective coating at 800 °C. The shank is unaffected (less than 300 °C).

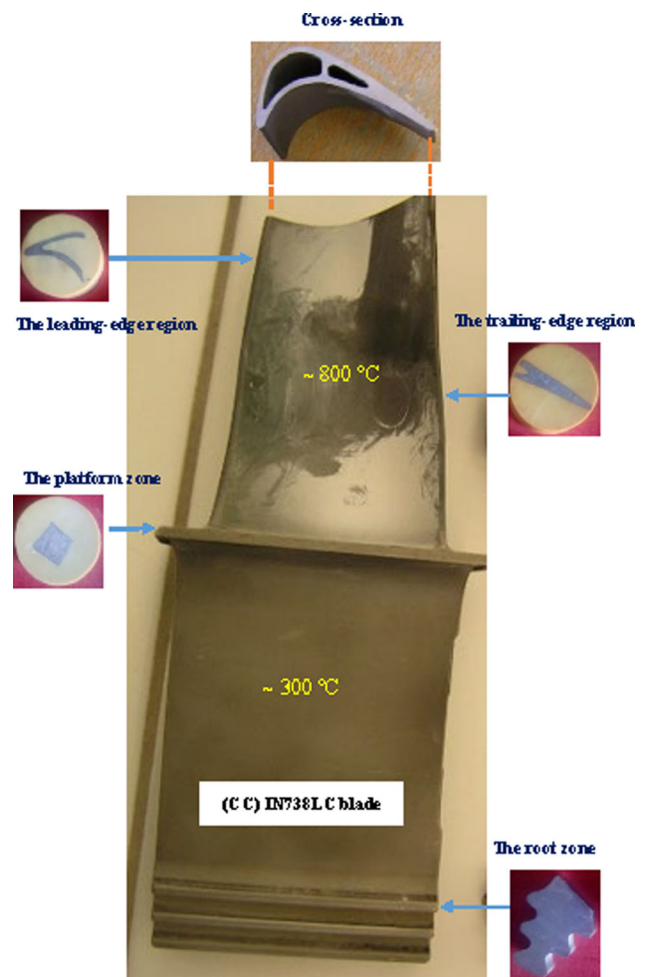
Fig. 2 Degraded IN738LC blade

combined hot corrosion/erosion effects. The (CC) IN738LC blade presented in Fig. 2 also displays the presence of dark-brown color at the airfoil hot section. The shank zone was free of degradation.

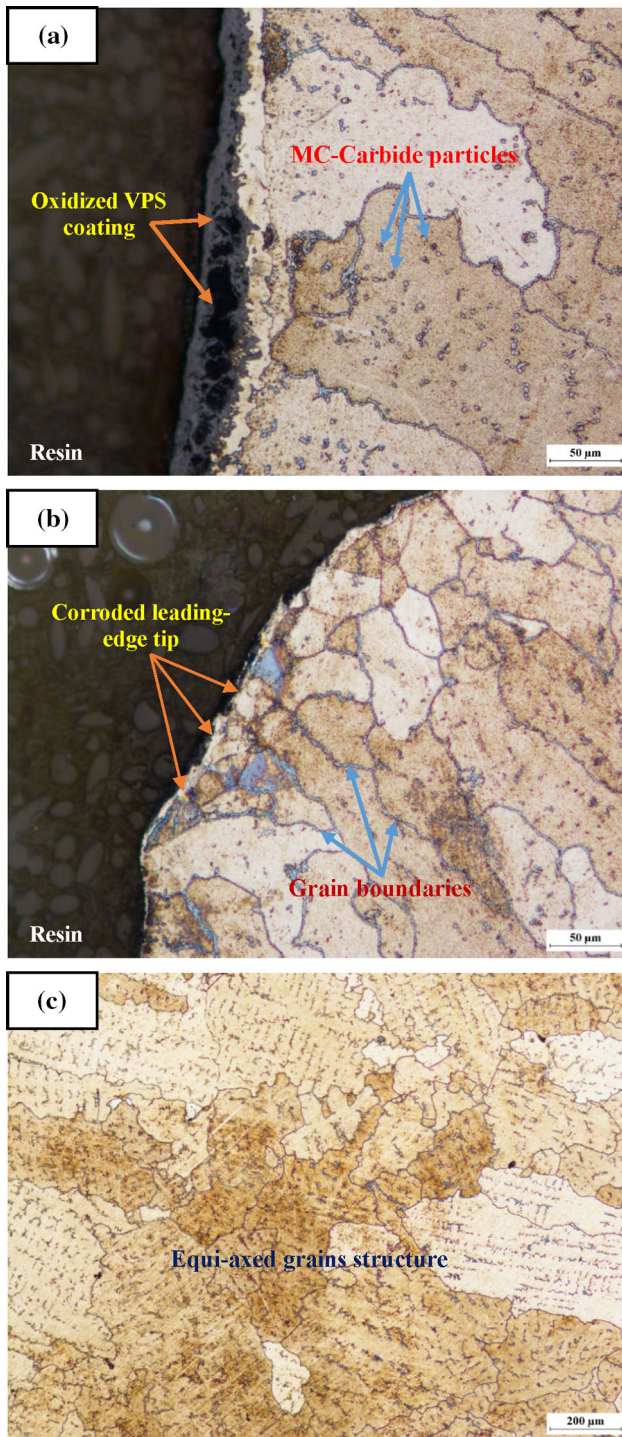
Fig. 3 Optical photomicrographs showing the grains structure of GTD-111 superalloy at the airfoil trailing-edge corroded region. (a) Oxidized VPS coating. (b) Corroded leading-edge tip. (c) Magnified view of grains structure

The corroded/oxidized trailing-edge zone (blue circle) shown in Fig. 1 was at first inspected using optical microscopy. The optical photomicrographs in Fig. 3 exhibit the conventionally cast (CC) structure of the GTD-111 nickel-based superalloy with its oxidized vacuum plasma spray (VPS) coating. The VPS coating deposited on GTD-111 substrate had sustained a severe hot corrosion in operation, as shown in Fig. 3a. Even worse, the corroded VPS coating had stripped off at the trailing-edge tip. Figure 3b shows the presence of a variety of MC-carbide particles in interior grain, and $M_{23}C_6$ -carbide lines at grain boundaries. According to Fig. 3c, the grains mean size in this degraded region is around $\sim 120 \mu\text{m}$. Figure 4a shows the conventionally cast structure of the corroded trailing-edge zone. In this cast, GTD-111 substrate two-grain structures were developed: columnar grains at the mold walls, and equiaxed grains at the center. As presented in Fig. 4b, the degraded trailing-edge microstructure reveals the presence of Cr-rich $M_{23}C_6$ -lines network at grain boundaries and elongated/globular MC-carbides within the grains. Additionally, the VPS coating had endured a high level of corrosion/oxidation attacks. Figure 5 displays the representative EDS spectra performed at the points 1, 2, and 3 mentioned in Fig. 4b. According to EDS spectrum (1), the non-oxidized VPS layer was found to have the following composition: 72.97Ni 16.08Co 5.9Cr 2.88Mo 1.77Al 0.24Si 0.16Ti (wt.%). Based on the spectrum (2), the MC-carbide particles precipitated within GTD-111 grains interior are rich in Mo, and Ti elements. EDS spectrum (3) confirms the precipitation of Cr-rich $M_{23}C_6$ -lines network at the grain boundaries of the degraded GTD-111 substrate. In addition, the EDS line scan results presented in Fig. 6 confirm the outward diffusion of (Al, Cr) coating elements due to high-temperature oxidation. The latter explains the formation of (Cr, Al) $_2\text{O}_3$ oxide scales. Small traces of Ti, Mo, Fe, and Co oxides were generated in the outer surface. At the non-oxidized zones of VPS coating, the element concentrations return to their near steady state.

It is clear from the optical micrographs of Fig. 3 that the microstructure of the corroded trailing-edge zone strata has evolved. The dark band at the outer surface of the VPS coating shown in Fig. 3a is attributed to the severe oxidation at 820 °C. In general, VPS coatings have good resistance to cracking and provide good refurbishment capability for the aged blade. The VPS coating at the trailing-edge tip was stripped off due to hot corrosion attacks, as shown in Fig. 3b. In addition, the equiaxed grains structure shown in Fig. 3c is a characteristic of the GTD-111 nickel-based superalloy. This grains morphology did not display any abnormality. From Fig. 4a, the small equiaxed grains generated at the outer surface of the GTD-111 substrate were a consequence of the rapid cooling near the wall at room temperature. These equiaxed grains grow in the reverse orientation to the heat flow out through the mold (columnar grains are present in the area with less undercooling). An intrinsic degradation was observed in the VPS/GTD-111 strata of the trailing-edge zone as shown in Fig. 4b. According to the EDS spectrum (1) of Fig. 5,

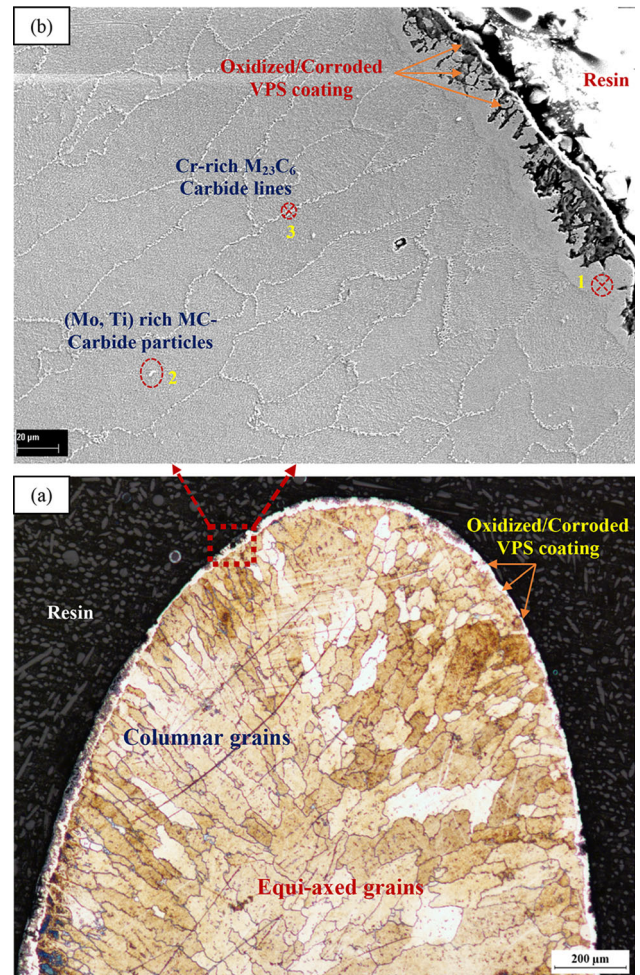
Fig. 4 Microstructure of the corroded/oxidized trailing-edge zone. (a) Optical photomicrograph of the trailing-edge tip. (b) Magnified SEM photomicrograph of the trailing-edge tip

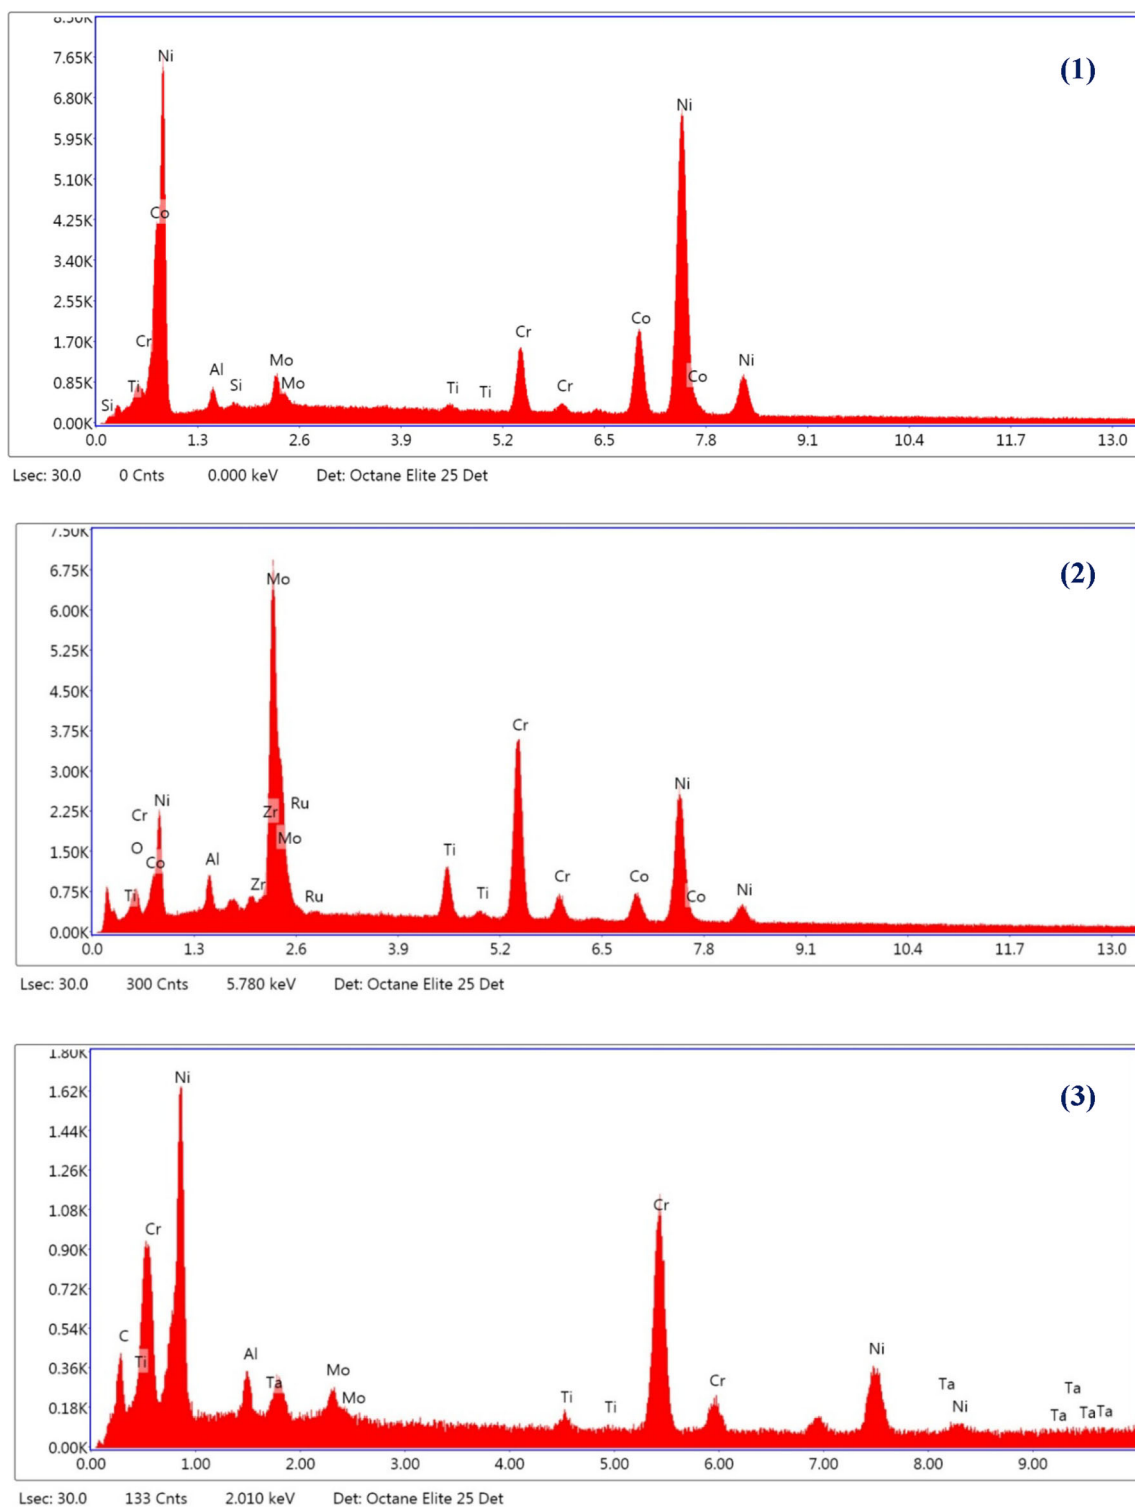
Fig. 5 Representative EDS spectra illustrating the elementary composition of: (1) the non-oxidized VPS coating. (2) The MC-carbide particles. (3) The $M_{23}C_6$ carbides

the VPS coating rich in NiCo elements shows the formation of (Al, Cr)₂O₃ oxides layer at the outer surface. This internal oxidation and continuous diffusion of O₂ into the interior quickly depletes the VPS coating of its available Al, Cr content. The presence of (Mo, Ti)-rich carbide particles in grains interior and M₂₃C₆ lines in the grain boundaries of the GTD-111 substrate was identified using the EDS spectra 2, and 3 of Fig. 5. Furthermore, the line profiles taken on VPS/GTD-111 strata as described in Fig. 6, confirm the diffusion and high concentration of (Cr, Al) elements at the outer surface of the VPS coating. This is due to the continuous formation of (Cr, Al)₂O₃ oxide scales during operation at 820 °C. Small oxide traces of Ti, Mo, Fe, and Co have been generated at the external surface of the VPS coating. A high concentration in Ni, and Co elements was detected in the non-affected coating zone and base substrate.

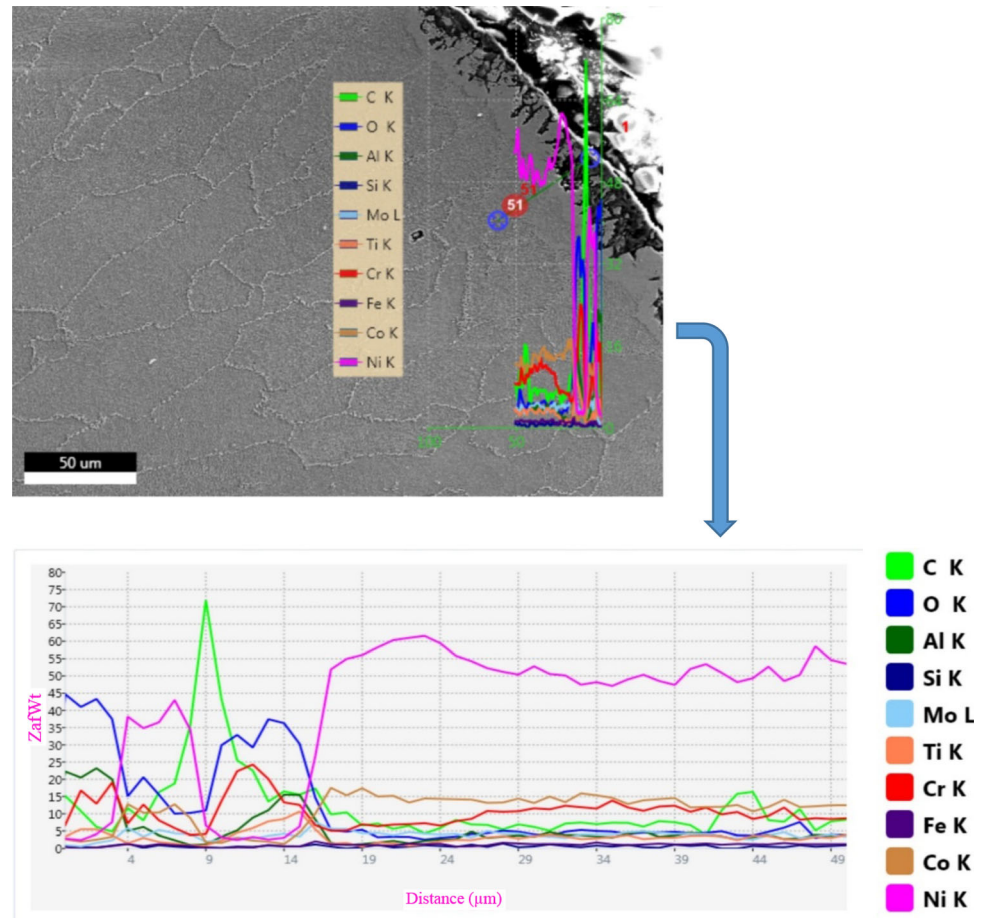
Fig. 6 Line profiles taken on VPS/GTD-111 strata of the oxidized trailing-edge region

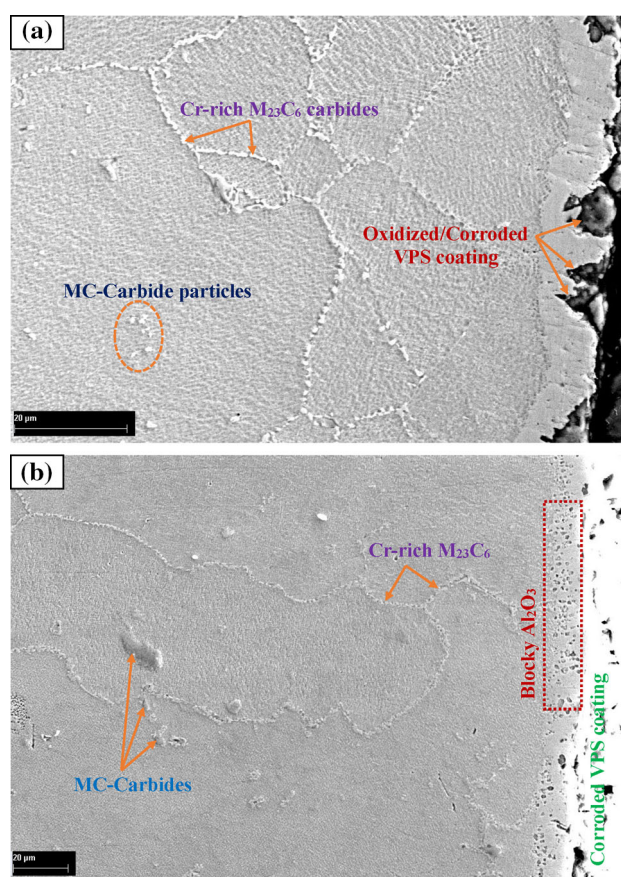
Moreover, the microstructure of the oxidized leading-edge zone is presented in the SEM micrographs of Fig. 7. This degraded region also contains a variety of MC-carbide particles and continuous lines network of Cr-rich $M_{23}C_6$ -carbides, as shown in Fig. 7a. According to Fig. 7b, the VPS coating of the leading-edge corroded/eroded zone was stripped off (the white circle shown in Fig. 1). However,

Fig. 7 SEM photomicrographs. (a) Microstructure of the oxidized leading-edge region. (b) Microstructure of the leading-edge eroded zone

According to Fig. 7a, the microstructure and morphology of VPS/GTD-111 strata at the leading-edge region exhibit a less degradation extent in comparison with the

trailing edge. In-depth examination of the corroded/oxidized leading-edge zone (pointed out by the white circle in Fig. 1) shows the formation of blocky Al₂O₃ oxide particles as shown in Fig. 7b. These Al₂O₃ oxide particles were the result of the O₂ diffusion into the GTD-111 substrate after the stripping off the VPS coating during operation. Figure 8 indicates the stability in elements concentration at the leading-edge strata. This steady state in the Ni, Co, Al, Cr, Fe, Ti, and Si concentrations is a sign of less degradation of leading-edge in comparison to the white circle region mentioned in Fig. 1. Figure 9a shows the presence of triangular γ' particles in the microstructure of the non-affected shank. In contrast, the γ' particles within blade leading-edge and trailing-edge take a spherical form as shown in Fig. 9b and c. From Table 2, it is clear that the initial γ' particles of 0.40 μm with a 39.8% volume fraction at the shank had grown up to 0.72 μm (45.48% volume fraction), and 0.98 μm (47% volume fraction) in the degraded leading-edge and trailing-edge, respectively. Based on expression (1), the degradation level of GTD-111

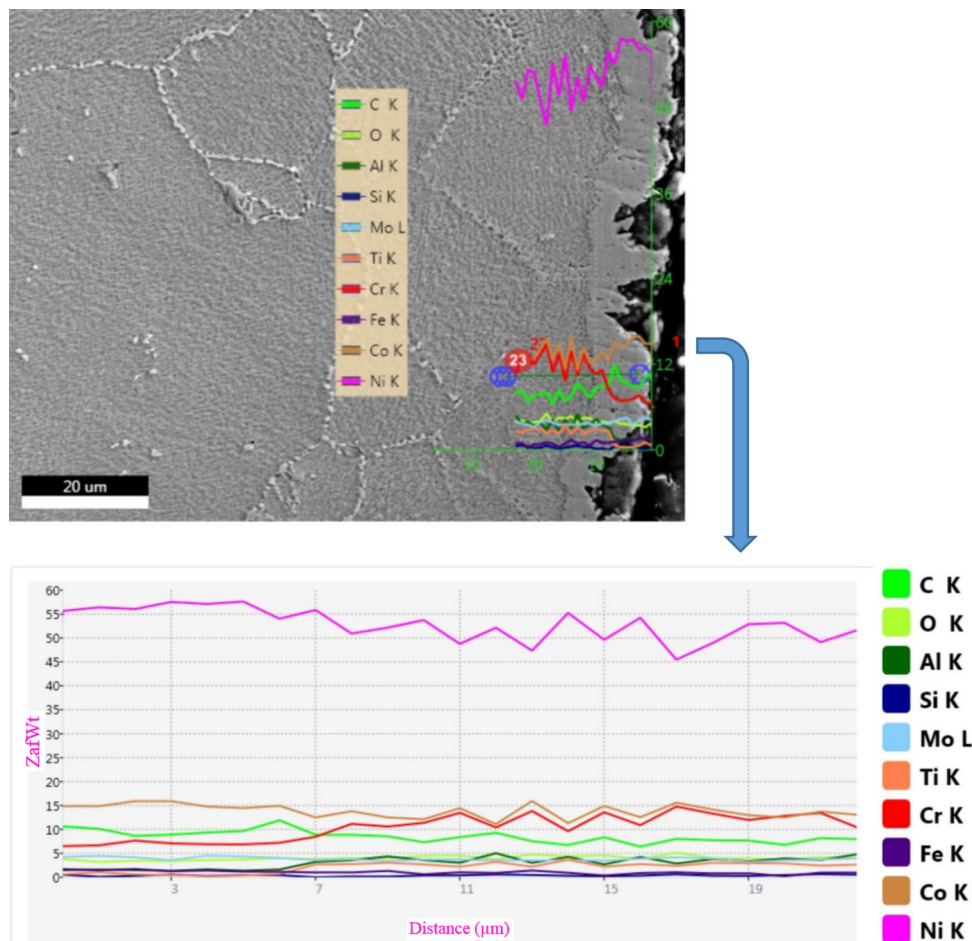
there is a diffusion band at the outer surface of GTD-111 substrate containing blocky Al_2O_3 oxides. The EDS line scan results presented in Fig. 8 show the stability in elements concentrations across the strata (non-oxidized VPS coating/GTD-111 substrate).

Fig. 8 Line profiles taken on VPS/GTD-111 strata of the oxidized leading-edge region

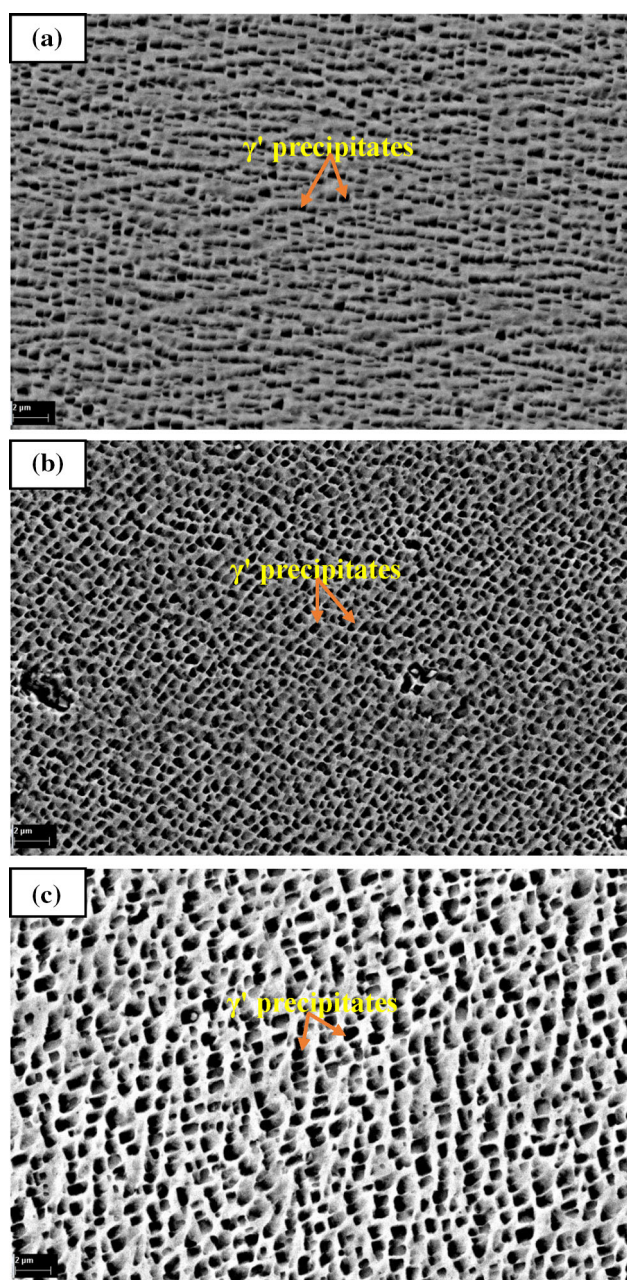
The main phenomenon occurring in the degraded blades is the coarsening and coalescence of γ' - $\text{Ni}_3(\text{Al}, \text{Ti})$ precipitates, as shown in Fig. 9. The FCC γ' (Ni_3, Al) mean size in the collected images is measured using ImageJ software, as given in Table 2. The newly introduced degradation index is based on the γ' precipitates mean size according to the following expression:

From SEM micrographs (Fig. 9), the γ' precipitates had changed from a triangular form in the shank zone to completely rounded shape in the corroded trailing, leading-edge regions. This evolution reduces the creep resistance of (CC) GTD-111 blade. The hardness mean values, shown in

Fig. 9 SEM micrographs showing the $\gamma + \gamma'$ microstructure in the different GTD-111 blade regions, (a) the shank, (b) the leading edge, (c) the trailing edge

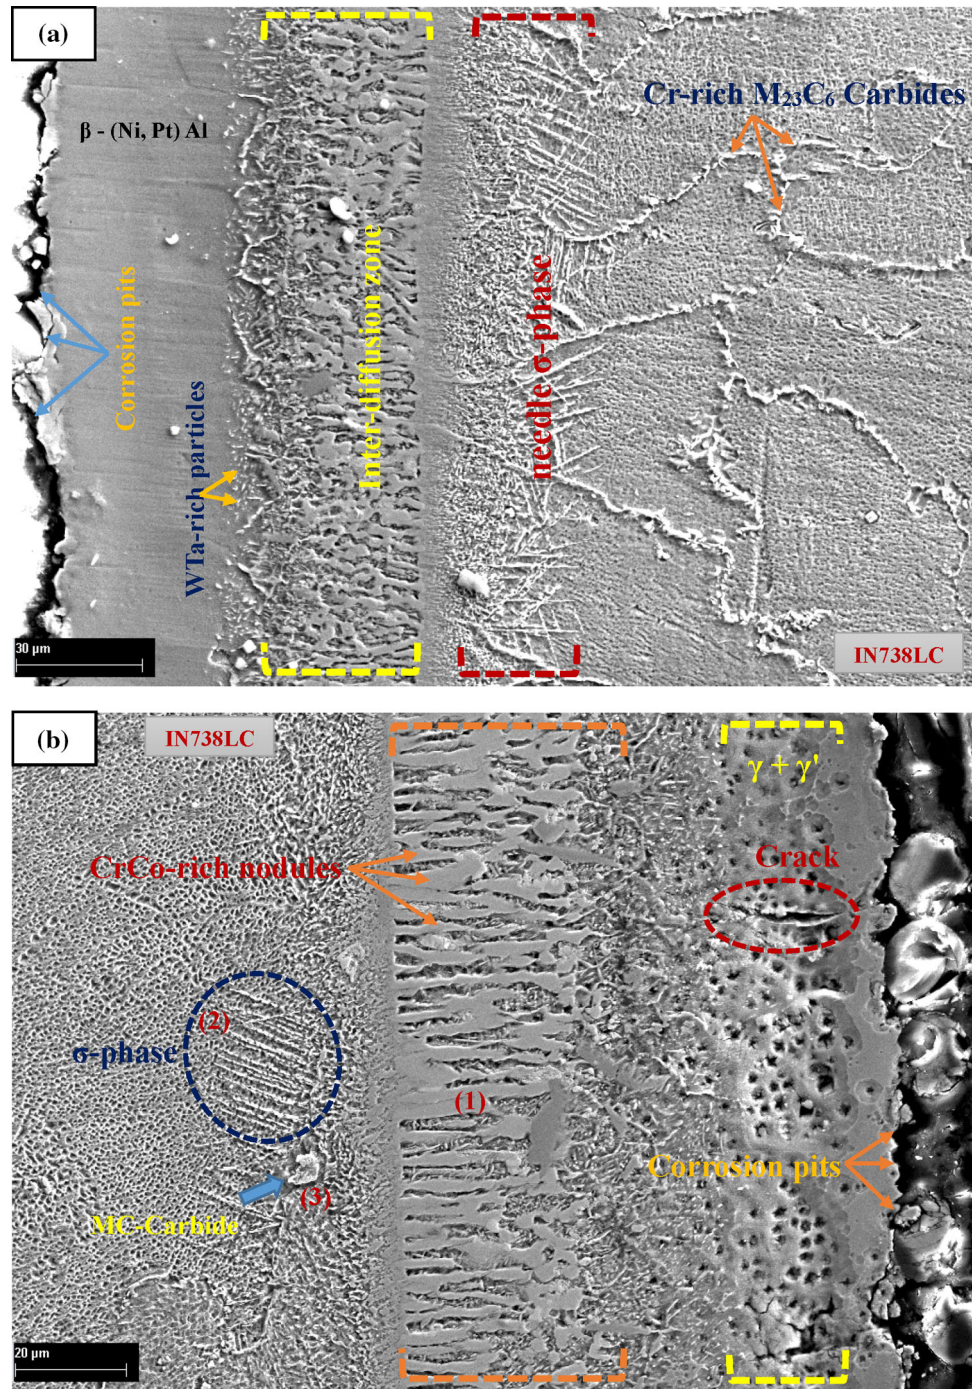
As shown in Fig. 10a, the leading-edge region strata (NiPtAl + IN738LC) shows a significant degradation in the substrate microstructure, and the formation of Al_2O_3 oxide scale and corrosion pits at the outer surface of coating. The β -(Ni, Pt)Al backbone layer of around $\sim 45 \mu m$ provides the reservoir surface of elements that will form a very protective oxide layer. A mixture of (Ti, Ta)Nb carbides, TaW particles, and (Ni, Co)Cr-rich elongated phases were precipitated in the interdiffusion zone of $\sim 39 \mu m$ thickness. The presence of the needle σ phase rich in (Ni, Co) Cr-W beneath the interdiffusion zone makes the IN738LC brittle during operation at $980^\circ C$ and reduces the blade creep resistance. The presence of continuous lines of Cr-rich $M_{23}C_6$ carbides at the grain boundaries was a result of the blocky MC-carbides (rich in Ta, Ti, and Nb) degeneration within the austenitic γ -matrix. These lines of $M_{23}C_6$ have an impact on the IN738LC substrate hardness properties. Based on Fig. 10b, the blade

trailing-edge zone displays a complete change of the β single phase into a $\gamma + \gamma'$ microstructure. This is the best moment for coating restitution (stripping and recoat). Several cracks initiated and propagated through the consumed β layer (changed to $\gamma + \gamma'$) and the interdiffusion zone. In addition, the IN738LC substrate under the interdiffusion zone was transformed into a fragile $\sigma + \gamma + \gamma'$ microstructure. The spectrum (1) of Fig. 11 indicates that the elongated nodules in the interdiffusion zone (Fig. 10b), are rich in Cr and Co elements. The spectrum (2) performed on the precipitated needle σ phase under the interdiffusion zone (Fig. 10b) shows high concentrations in (Ni, Co) Cr-W elements. According to spectrum (3) of Fig. 11, the white particles designated by (1) in Fig. 10b are rich in Ti, Ta, and Nb.

Fig. 10 SEM Micrographs illustrating the morphology of IN738LC/NiPtAl strata, (a) in the leading-edge zone, (b) in the trailing-edge zone

From the SEM micrograph of Fig. 10a, oxidation/corrosion of β -NiPtAl coating had provoked elements interdiffusion between the underlying IN738LC and the NiPtAl coating. The interdiffusion zone (IDZ) contain an elongated phase rich in (Ni, Co) Cr together with (Ti, Ta) Nb and (W, Ta) carbide particles. In addition, a needle σ phase was precipitated in the $\gamma + \gamma'$ microstructure beneath interdiffusion zone. It is known that this needle σ phase generated during operation have an impact on the creep resistance of the IN738LC blade [36]. The Al_2O_3 oxide scales are the result of the β -coating reaction with the exhausted hot gases. The precipitated $M_{23}C_6$ -lines result from the degeneration of the irregular blocky MC-carbides within the γ -matrix of the IN738LC substrate. These $M_{23}C_6$ -lines are rich in (Al, Cr, Ni, and Ti), while the isolated MC-carbides are rich in (Ta, Ti, and Nb). The local change in the composition of β -phase at the corroded/oxidized trailing-edge (Fig. 10b) is thought to be a consequence of aluminum loss, by diffusion in two directions toward the substrate and the outer surface of the coating. Oxidation in the β -layer reduces the amount of aluminum, which becomes lower and lower due the interdiffusion. The original β -phase had been transforming into a biphasic $\gamma' + \beta$ then to a $\gamma + \gamma'$ structure until attaining a lamellar structure. At this point, it becomes necessary to carry out blade refurbishment. Both inward diffusion of Al, Pt and outward diffusion of Co, Cr, Ti elements from IN738LC superalloy contributed to the transformation and consumption of the NiPtAl coating. EDS spectra (Fig. 11) obtained for areas marked 1, 2 and 3 in Fig. 10b, confirmed the nucleation of (Cr, Co) rich elongated nodules at the interdiffusion zone, and precipitation of needle (Ni, Co)Cr-W phase mixed with blocky (Ti, Ta)Nb carbides beneath the interdiffusion zone. Another important feature that occurred in Zr doped NiPtAl layer at the blade platform is the presence of thermal fatigue cracks due to the low strength and near full consumption of the coating, as shown in Fig. 12a. A multitude of C_3Al_4 precipitates were generated at the interdiffusion zone. The tortuous grain boundaries presented in Fig. 12b makes the blade more resistant to deformation. As shown in Fig. 14a, the continuous pitting corrosion and erosion attacks within the blade-cooling channel provoked the stripping of NiPtAl layer. The variety of micro-voids and C_3Al_4 particles generated in the β -layer (Fig. 14b) are also thought to be due to oxidation/corrosion attacks. The EDS spectrum in Fig. 15 indicate the formation of many $(Al, Cr)_2O_3$, Fe_2O_3 oxide scales. A needle σ phase rich in (Ni, Co)Cr-W was precipitated beneath the interdiffusion zone. In addition, the (Ti, Ta)Nb particles found within the unaffected shank microstructure as shown in Fig. 16a, are identified using

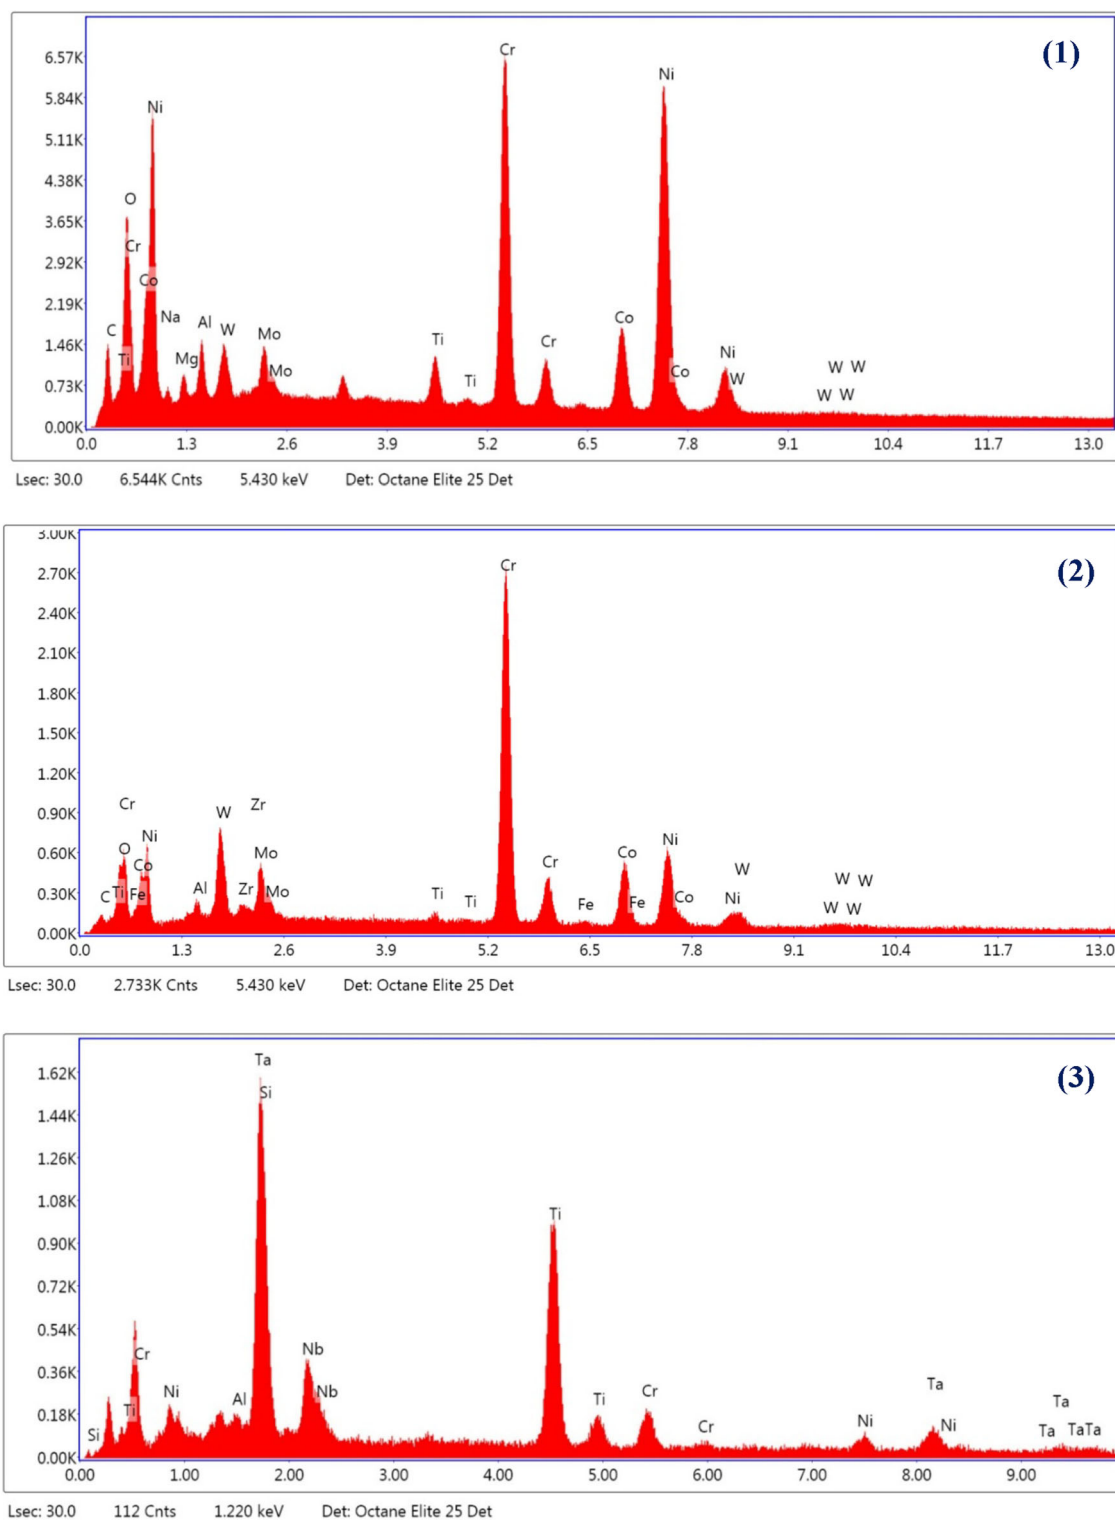
Fig. 11 EDS spectra, (1) of the CrCo-rich nodules, (2) of the σ phase, (3) of the (Ti, Ta)Nb rich carbide particles

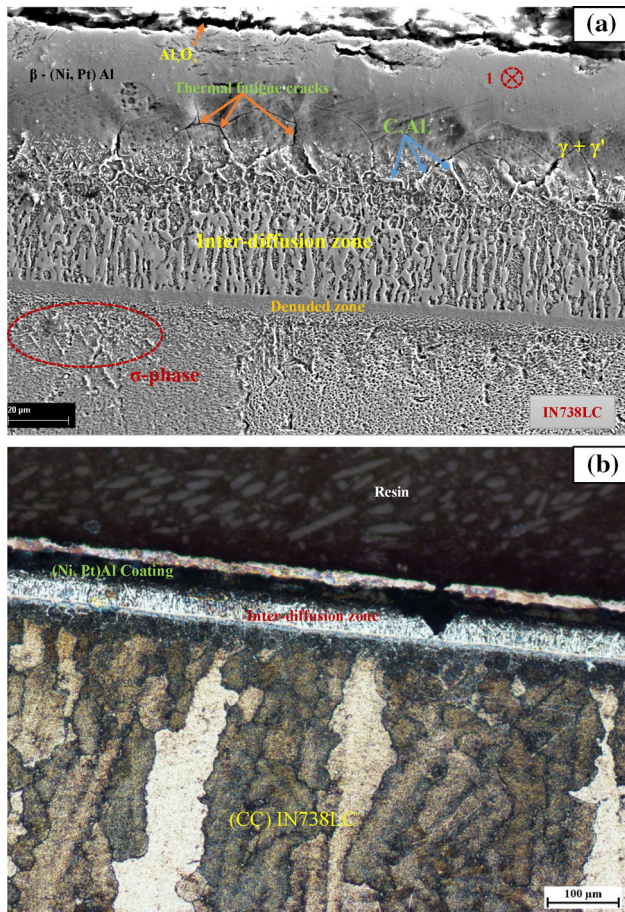
The continuous oxidation of β -layer promotes the interdiffusion of various elements between the aluminide coating and (CC) IN738LC substrate as shown in Fig. 12a. This leads to the occurrence of γ' phase within the fragile β layer because it depends on the Al, Pt contents. Several cracks initiated in the $\beta + \gamma'$ layer, may propagate by thermal-fatigue into the IN738LC substrate. Addition of Zr has a significant effect on oxidation behavior of the Pt-

Fig. 12 Microstructure of the blade platform. (a) SEM micrograph of NiPtAl/IN738LC strata. (b) Optical micrograph of NiPtAl/IN738LC strata

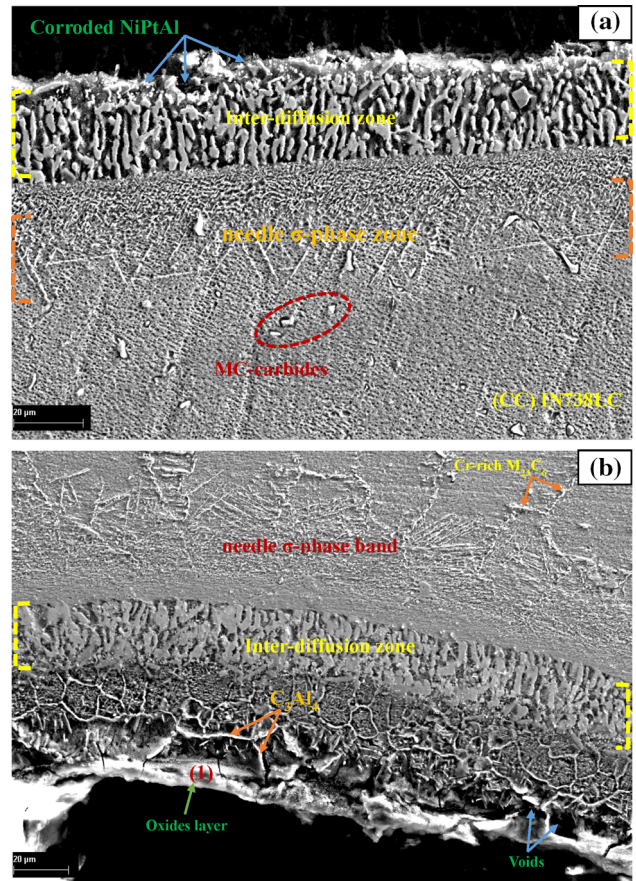
Fig. 14 SEM micrographs of the cooling channel internal wall. (a) Stripping of β -layer. (b) Micro-voids formation within β -layer

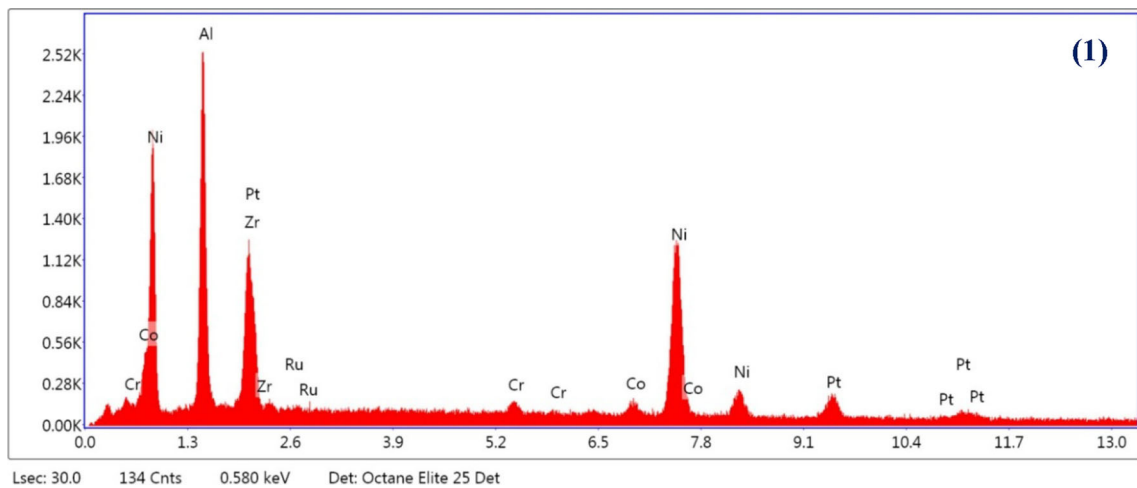
Fig. 13 EDS spectrum of the degraded β -layer

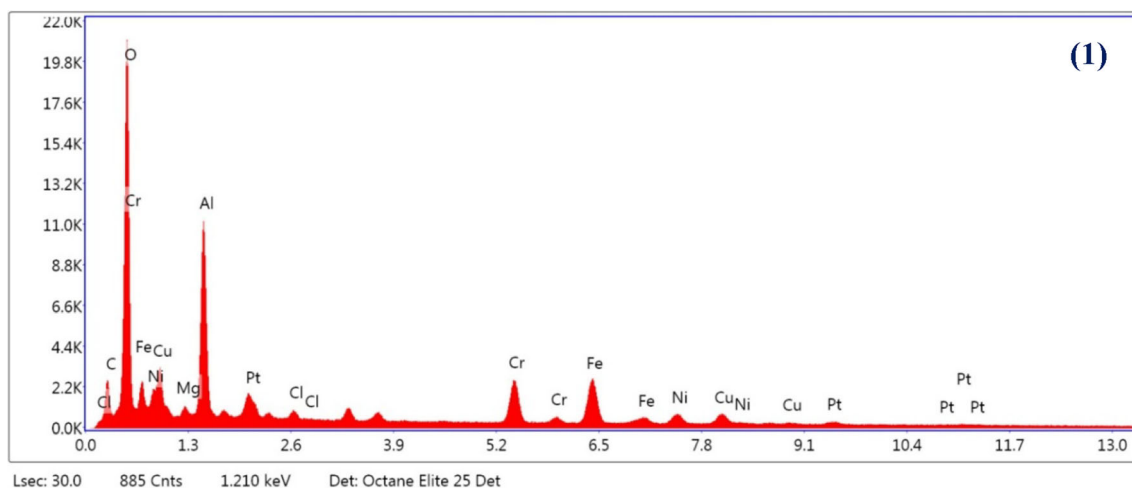
Fig. 15 EDS spectrum of the oxidized β -layer

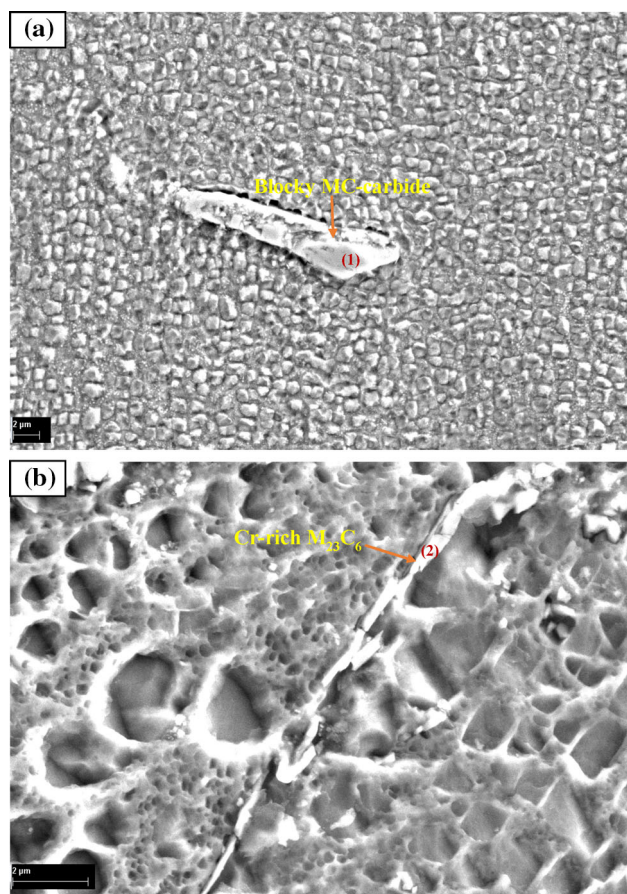
Fig. 16 SEM micrographs, (a) of the (Ti, Ta) Nb carbide particles in the shank, (b) of the $M_{23}C_6$ lines in the airfoil hot section

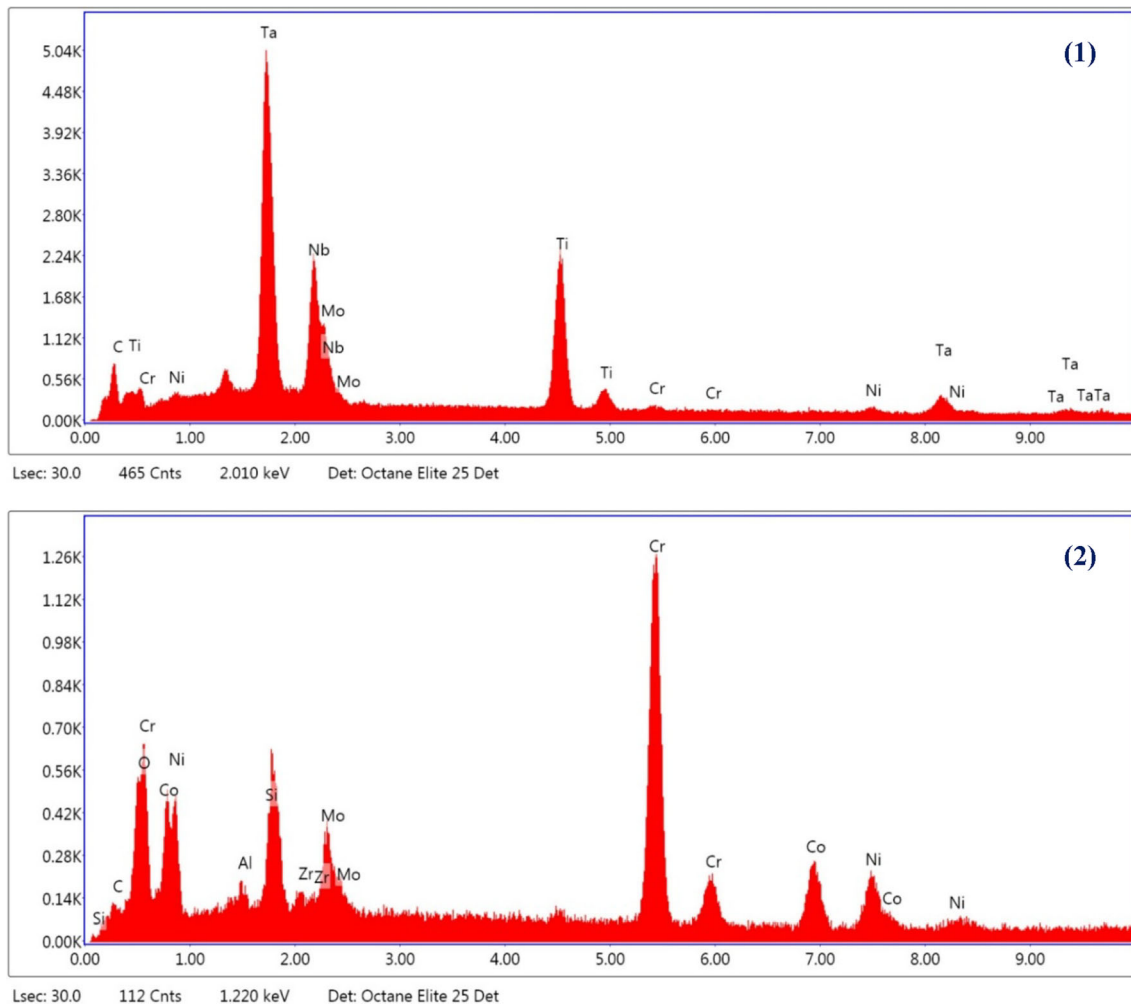
Fig. 17 EDS spectra, (1) of MC-carbide particles, (2) of M₂₃C₆ carbides

the EDS spectrum (1) of Fig. 17. These particles had degenerated during operation at ~ 800 °C according to the following reaction $(\text{Ti, Ta}) \text{Nb} + \gamma \rightarrow \text{M}_{23}\text{C}_6 + \gamma'$. The precipitation of M_{23}C_6 carbides at the grain boundaries of IN738LC substrate displayed in Fig. 16b is identified by EDS spectrum (2) of Fig. 17. The blade shank was found to consist of an austenitic γ matrix strengthened by two kinds of FCC γ' - (Ni_3, Al) precipitates (Fig. 18a): $0.52 \mu\text{m}$ secondary γ' precipitates with 34.22% volume fraction, and $0.1 \mu\text{m}$ tertiary γ' precipitates. These particles act as obstacles during operation against dislocation movement within superalloy $\gamma + \gamma'$ microstructure. The key phenomenon occurring in IN738LC blades is the secondary oval γ' particles growth from $0.84 \mu\text{m}$ with 37.47% volume fraction at the leading-edge to $1.11 \mu\text{m}$ with 39.71% volume fraction at the trailing-edge. From Fig. 18b and c, the mean size of tertiary γ' particles in the airfoil region estimated at $0.2 \mu\text{m}$. The degradation (D_i) values mentioned in Table 2 show a good agreement between the γ' mean size and the IN738LC blade degradation level. Based on the increase in hardness (Table 3) from 430 (Hv) at the shank up to 619 (Hv) at the airfoil section is attributed to the formation of needle σ phase beneath the interdiffusion zone, the coarsening of γ' precipitates, and the M_{23}C_6 lines network formation at the grain boundaries. The growth (from 20.45 to 39.45 nm) and the orientation changes of γ' crystallites, as shown in Fig. 19 justify the degradation in hardness properties of the IN738LC blade.

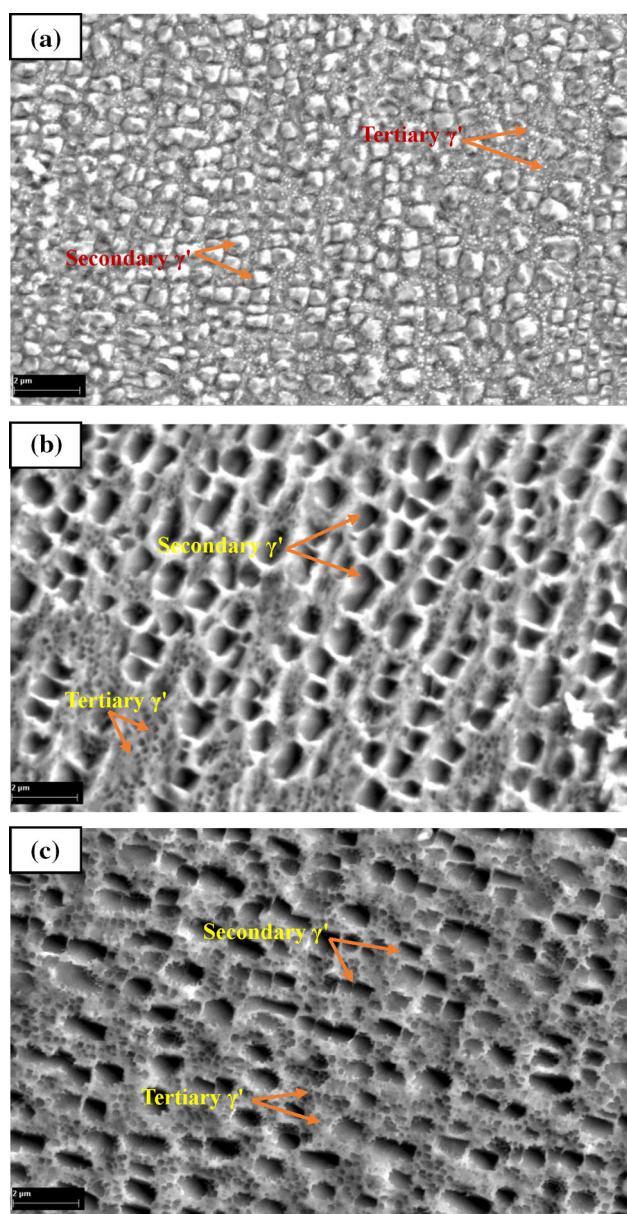
Fig. 18 SEM micrographs showing the $\gamma + \gamma'$ microstructure in the different IN738LC blade regions. (a) The shank. (b) The leading edge. (c) The trailing edge

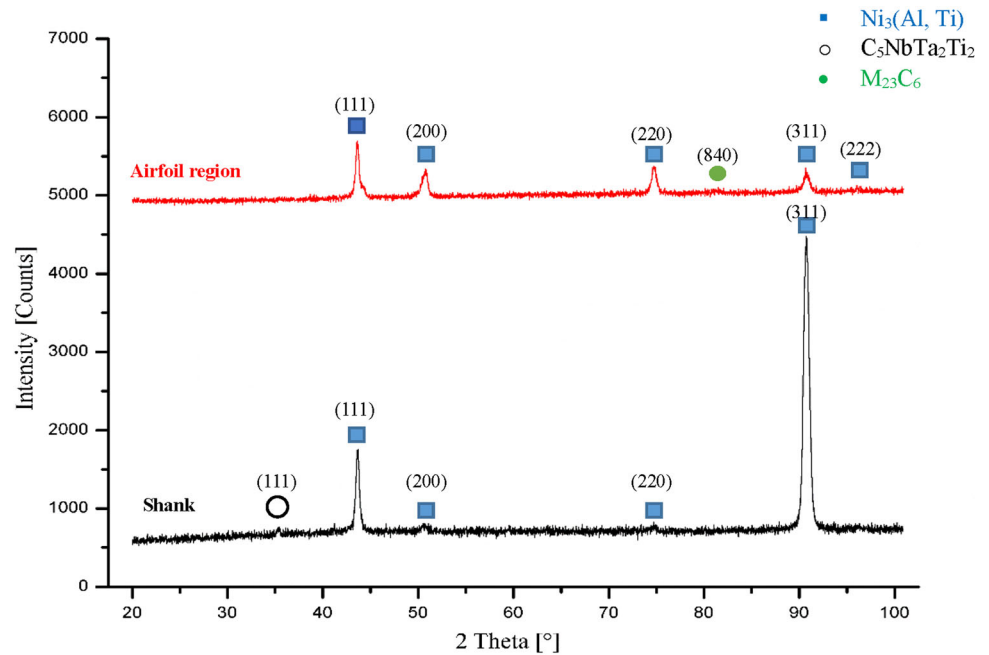
The mean size of γ' crystallites varied from the 20.45 nm in the shank to 39.45 nm in the airfoil. Consequently, the growth and orientation changes of γ' crystallites are considered as indicators of the plastic deformation (intrinsic strain).

Fig. 19 X-ray diffraction (XRD) patterns of the non-affected shank and the degraded airfoil region
