A Technique for Identifying and Characterizing the Microcracks Produced in Machined Surfaces

¹M. Gaceb and ²D. Gillibrand

Key words: Microcracks, surface integrity, machined surface, transmission electron microscopy

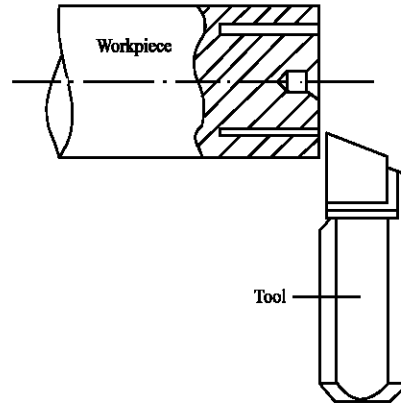
Fig. 1: Orthogonal machining operation

Machining tests: The machining tests were conducted on a Churchill Denhams model Srioiv 22 swing centre lathe with infinitely variable speed control (from 0-2000 rev min⁻¹) and a 30 kW power. The workpiece was pre-machined to obtain an annulus of 5 mm thickness at the free end of a cylindrical bar so as to allow orthogonal machining as shown in Fig. 1. Machining was done under dry cutting conditions. The cutting tools used were steel cutting grade P20 carbide tips brazed on a medium carbon tool holder so as to give a 5° rake angle and a 7° clearance angle. Each cutting test was conducted using a freshly ground cutting edge to avoid the eventual effects of cutting tool wear.

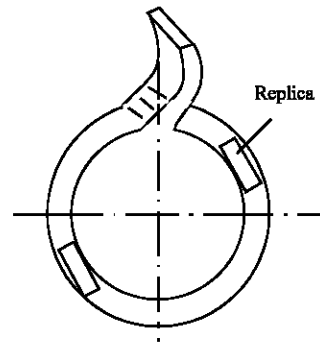
Fig. 2: Machined surface with attached chip

Replication of the machined surface: Prior to replication each machined surface is carefully degreased and washed in acetone before ultrasonic cleaning in trichloroethylene. The surface is then replicated at two random positions around the annulus (Fig. 2). A two stage plastic-carbon replication procedure with gold/palladium (60/40) shadowing was adopted. The replication consists of

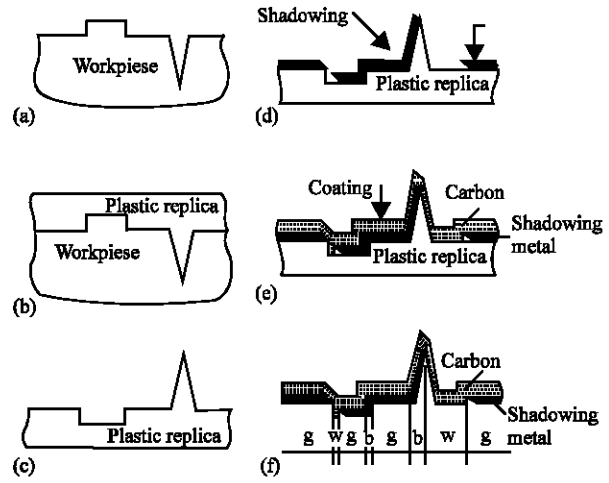
Fig. 4: Surface replication procedures (a) profile to be replicated (b) surface replication (c) plastic replica (d) Au/Pd shadowing (e) Carbon coating (f) Replica with dissolved plastic showing the contrast shade sequence

The shadowed and coated replica is finally cut into small squares whose size allows them to be mounted on 3 mm diameter copper support grids with the carbon coating facing downwards and immersed in acetone to dissolve the plastic substrate leaving the two stage replica of the machined surface. The complete procedure of the TEM specimen preparation is summarized in Fig. 4.

Figure 4 (f) shows the contrast shade sequences for a given surface. The sequence for a microcrack is Grey-Black-White-Grey (GBWG) as shown in Fig. 5. A micrograph showing the contrast shade sequence of a microcrack in the shadowing direction is shown in Fig. 6. Given a 45 degree shadowing angle to the surface, the measurement of the width of the white shade in the shadowing direction constitutes a direct measurement of the microcrack depth. The arrow indicates the shadowing direction which is also at 45° to the cutting direction.

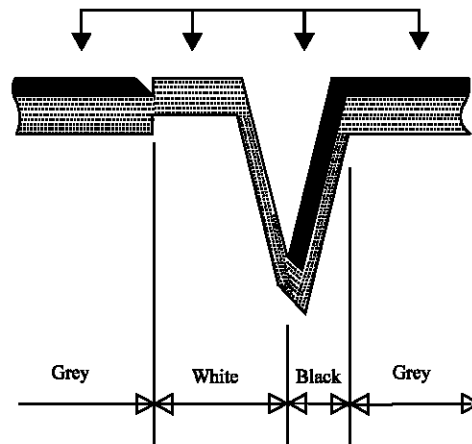
Fig. 5: Contrast shade sequence of a microcrack

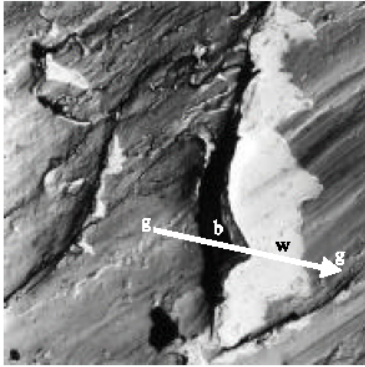
Fig. 6: Micrograph showing the microcrack

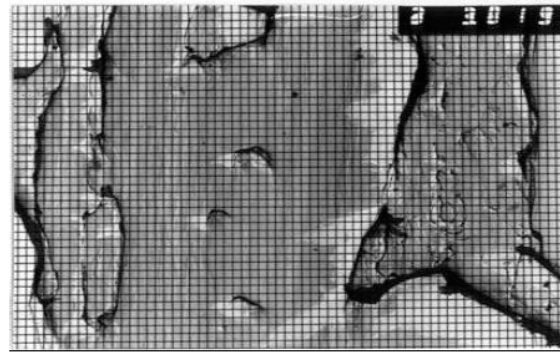
Fig. 7: Grid pattern for MAR measurement

To measure the microcrack area, a grid pattern 84 by 57 mm is superimposed upon the micrograph of the surface under consideration as shown in Fig. 7. The microcrack area is obtained by counting the squares of the grid pattern which fall within the white shade of the contrast pattern corresponding to microcracks. The counting is done manually although it is suggested to do this automatically directly in the transmission electron microscope or using some computer image processing means in future study.

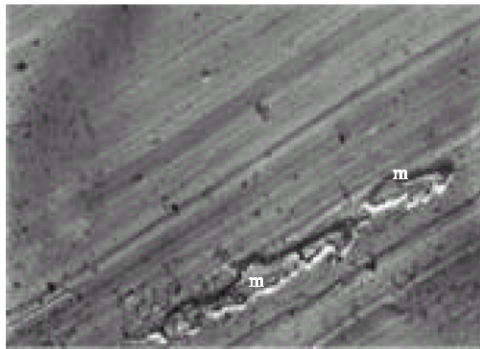
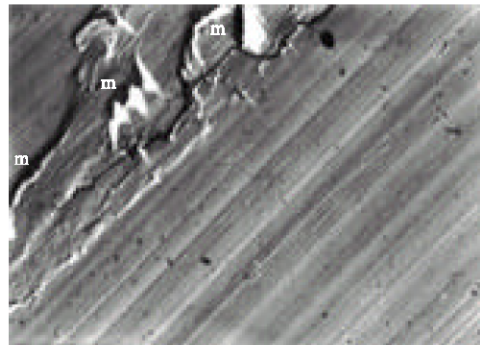
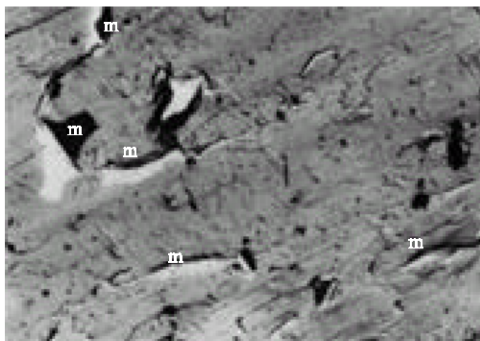
Fig. 8: Micrograph of the machined surface of (a) The stainless steel (b) The medium carbon steel (c) The free cutting steel

The results show that the extent of microcracking is greatest for the free machining steel and least for the stainless steel. The number of microcracks however is more or less the same in this case. This seems to suggest that the size of the microcracks decreases from the leaded resulphurized free cutting steel (A) to the stainless steel (C).

Visual confirmation of these results is provided by typical micrographs of the surfaces obtained for the three materials as shown in Fig. 8a-c. The microcracks are designated by the letter m.
