Autopsy of an old reverse osmosis membrane from Cap Djenet seawater desalination plant: case study of Algeria

S. Talantikite¹, K. Benrachedi¹

¹Food Technology Research Laboratory (LRTA) Faculty of Sciences Engineer
University of M'hamed Bougara, Boumerdes, 35000 Boumerdes–Algeria

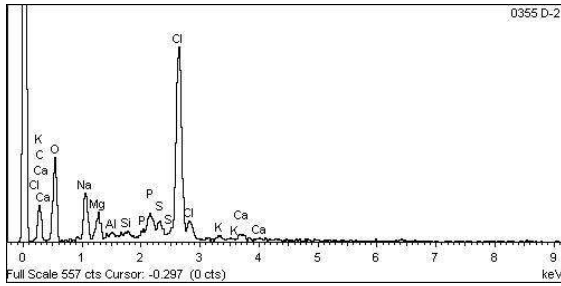
Figure 7. Analysis of area 1 on GA160355 membrane fouling (Spectrum 2F)

The general analysis of GA160355 membrane fouling indicates that fouling is composed by an organic component, sodium chloride, aluminosilicates, calcium, and common elements on sea water membranes fouling as sulphur, magnesium, phosphorous and potassium (Figure 6). While the analysis of area 1 on GA160355 membrane fouling indicates that fouling is composed by an organic component with chlorine, sodium chloride small percentages of the rest of elements detected on the general analysis carried out on membrane surface sample (Figure 7).

Element	App	Intensity	Weight%	Weight%	Atomic%
	Conc.	Corrn.		Sigma	
C K	6.74	0.1388	38.47	5.10	50.09
O K	14.64	0.2908	39.81	3.48	38.92
Na K	3.55	0.6612	4.26	0.44	2.89
Mg K	1.16	0.6140	1.49	0.20	0.96
Al K	0.17	0.7232	0.19	0.09	0.11
Si K	0.17	0.8270	0.16	0.09	0.09
P K	0.88	1.2392	0.56	0.16	0.28
S K	1.18	0.8175	1.14	0.19	0.56
Cl K	12.05	0.7295	13.07	1.14	5.77
K K	0.37	0.9002	0.33	0.09	0.13
Ca K	0.57	0.8736	0.51	0.11	0.20
